BK060 INSTALLATION INSTRUCTIONS

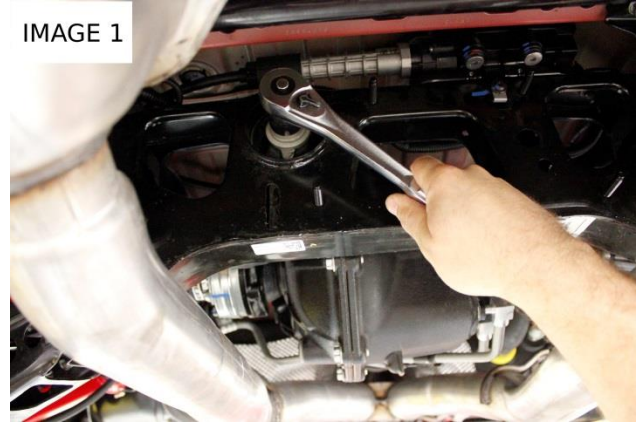
IMAGE 1

1. Lift vehicle and safely support with jack stands. Ensure jack stand placement does not interfere with the differential center section or the exhausts.
2. Using a 24mm socket, remove the large bolt at the rear of the cradle, as shown in **IMAGE 1**.
3. Support the rear differential center section with blocks or a jack, as seen in **IMAGE 2**.
4. Remove the front differential bolts with an 18mm socket and wrench as shown in **IMAGE 3**.
5. Supporting the rear muffler box, remove exhaust hangers with a prybar as shown in **IMAGE 4**.

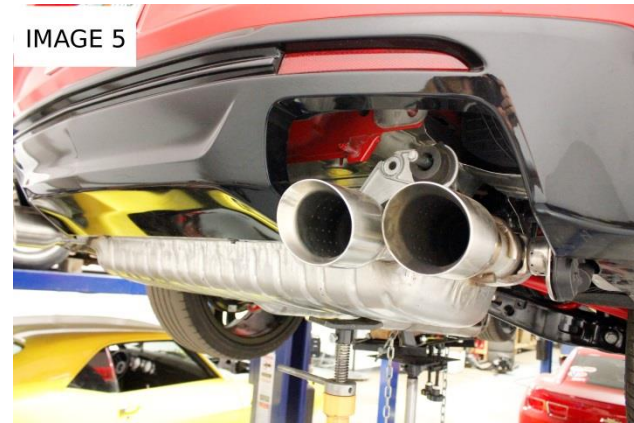
- Lower exhaust roughly 8 inches as seen in **IMAGE 5**.

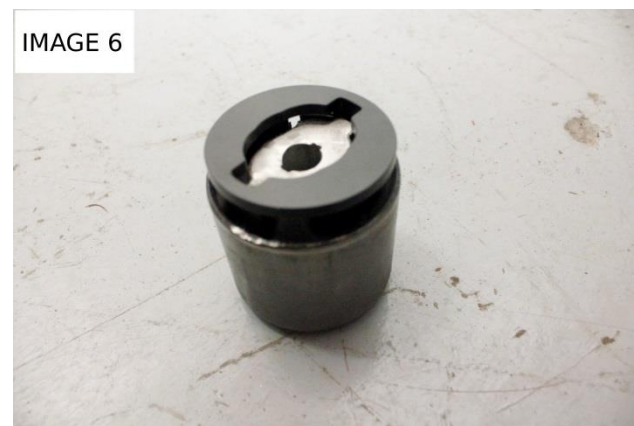
- For reference, the front bushing lockouts install on the factory bushings as seen in **IMAGE 6**.
