**Congratulations! You have just purchased the best engineered, dyno-proven exhaust system available.**

**Part number SES7300**  
**2016-2017 Chevrolet Camaro**  
**2.0L turbo 4cyl.**  
**1- 6 piece cat back exhaust**  
**5- 3.00 gasket (#17060)**  
**10- M10 hex bolt (#6038)**  
**10- M10 hex nut (#6069)**

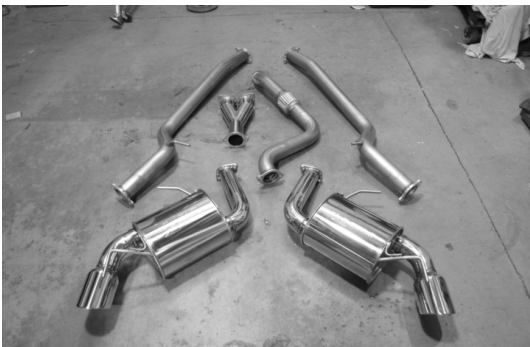
**Figure 2**

**Complete kit:**

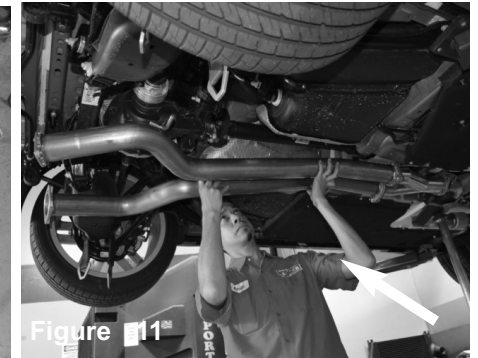
Figure 11

Install the mid assembly. Install the hangars to the rubber isolation mounts.

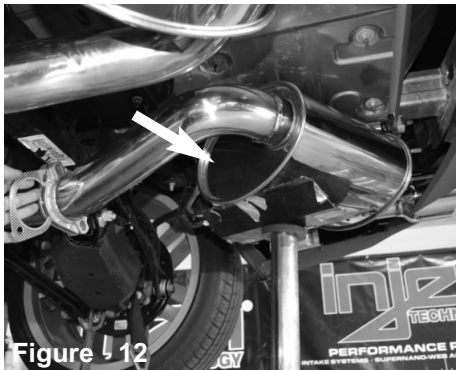
Figure 12

Install the rear muffler sections. Secure using provided 3" gaskets and bolts with nuts. **Do not tighten.**

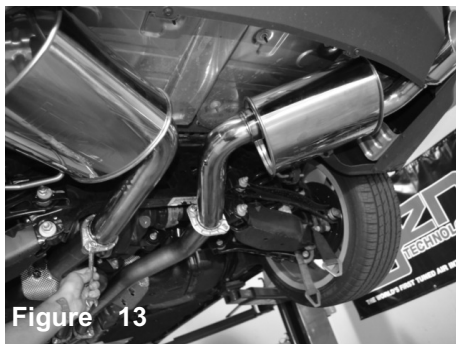
Figure 13

Snug fit all bolts and nuts using 14mm socket or wrench. Adjust for clearance and fitment. Make sure tips are centered of exhaust hole cut-out on bumper. Re-adjust if necessary. Use and extra hand for position of muffler and tighten all bolts and nuts.

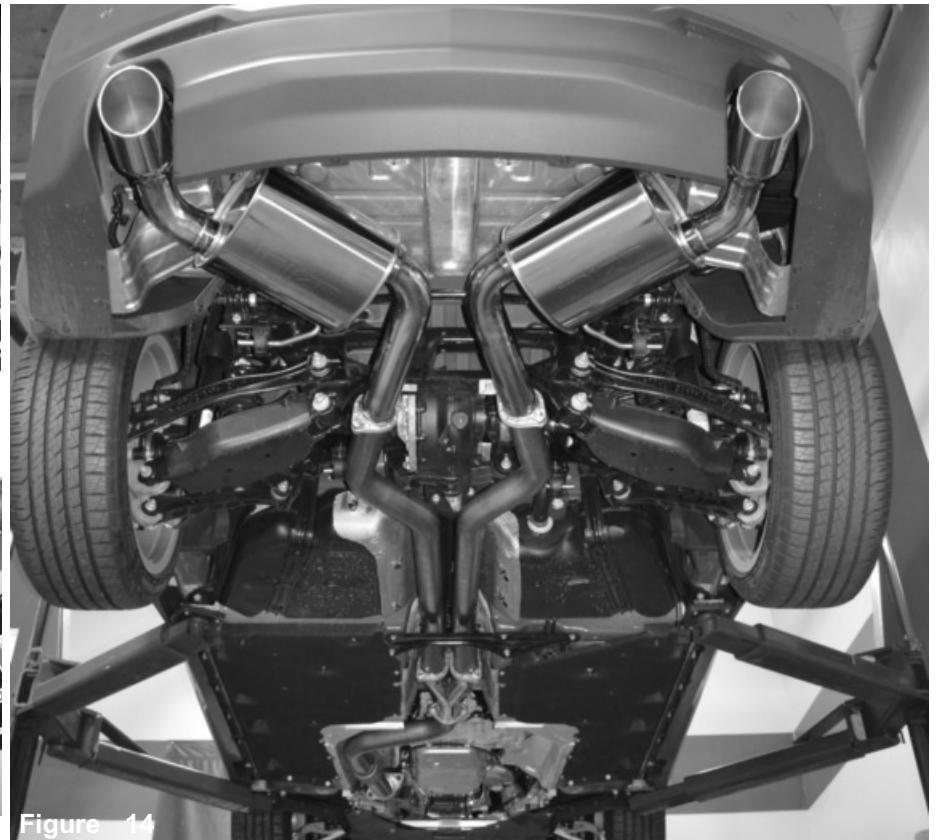
Figure 14

Congratulations! You have just completed the installation of this exhaust system. Periodically, check the alignment of the exhaust, normal wear and tear can cause nuts and bolts to come loose. **Note: Check clearance and adjust if needed! Failure to check the alignment and adjust the exhaust can cause damage that will void the warranty. Injen Technology is not responsible for any damages caused by/from improper installation.**
